CRITICAL ASPECTS IN BAIA MARE BASIN (THE SOUTH-WESTERN SECTOR)

AURELIA-DANIELA LAZĂR¹, GABRIELA-ALINA MUREȘAN²

ABSTRACT. – **Critical Aspects in Baia Mare Basin (the South-Western Sector).** A critical region is a territorial system that has one or more negative elements or interrelations, that can radically deteriorate its state. Sometimes, a territorial unit cannot be defined as critical in its entirety, but contains several critical aspects, generated by instability factors which lead to natural and/or man-made risk phenomena. This paper is focused on the south-western part of the Baia Mare Basin. Several critical aspects have been identified in this area, either induced by natural causes (landslides, ravinement) or by the society (industrial restructuring, demographic aging).

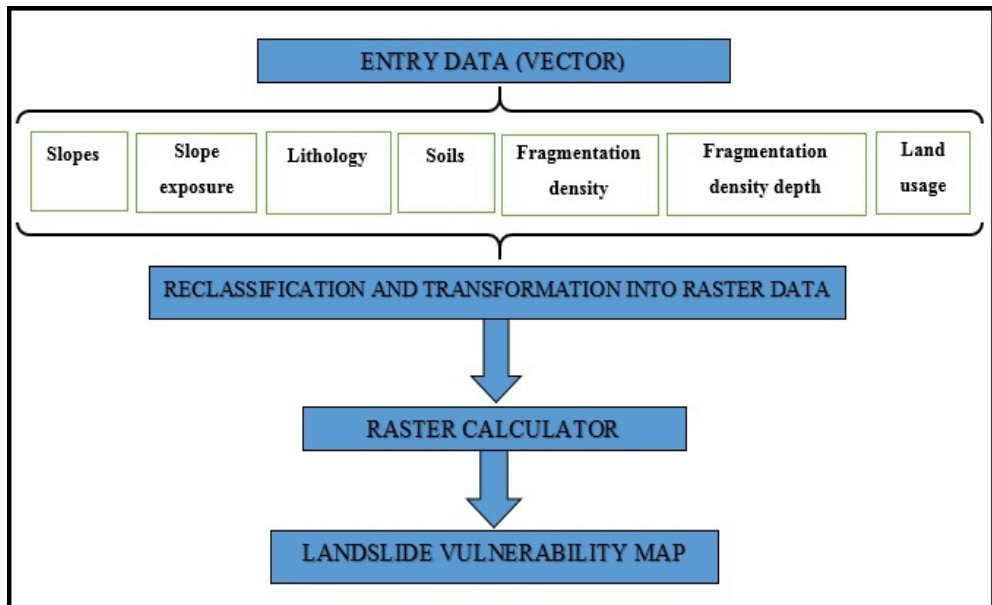
Fig. 1. The methodology used for generating the landslide vulnerability map

In order to generate the landslide vulnerability map, we employed two new factors, apart from the five ones used in generating the ravinement vulnerability map - fragmentation density and fragmentation depth (fig. 1). We also reclassified the seven thematic maps, transforming them into raster data. We then summed them up using GIS (Raster Calculator), the result being the vulnerability to landslides map.

and transformed vector data into raster data, according to the vulnerability index (very low, low, medium, and high vulnerability). Raster reclassification was based on subjectively attributed scores for each component element of the five factors. Following the processes of thematic map reclassification, transformation into raster system and summing them using the Raster Calculator tool in GIS, we obtained a map of the degree of vulnerability to ravinement.

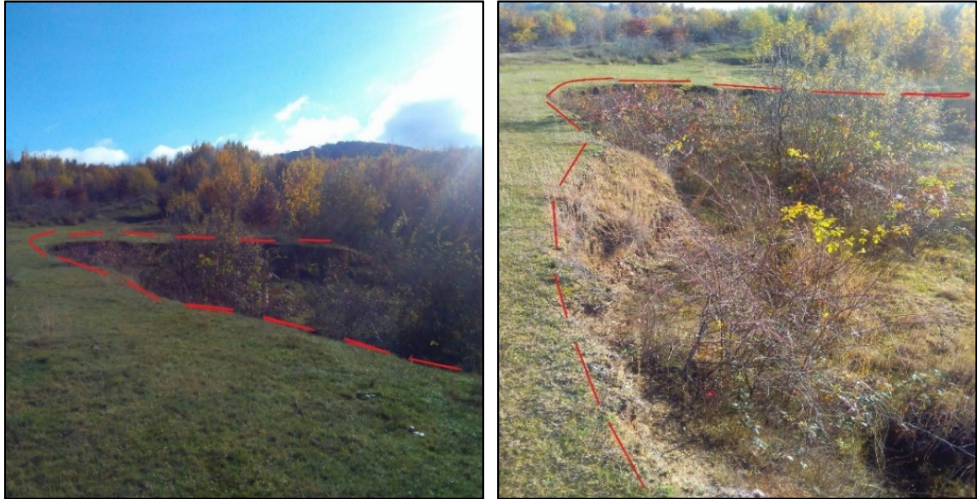
Fig. 3. Landslide in Chelița

The most serious problems are found in Chelița, where an old landslide was reactivated in 2011, damaging 19 houses. Three families had to be relocated in modular homes. The landslide occurred from East to West, the same direction as the flow of rain and underground water. This is due to the fact that the riverbed (Hotarului River) is obstructed near road DJ 108E, contributing to the erosion of the embankment. Most buildings are illegal and made of clay (adobe); thus, no owner has any home insurance, as the community's primary sources of income are welfare grants and child allowances (fig. 4).

In spite of small altitude differences, the landscape is somewhat vulnerable to many geomorphological processes, as there are large areas affected by landslides and ravinement in Chelița, Gârdani, Vicea and Mânău (fig. 3).

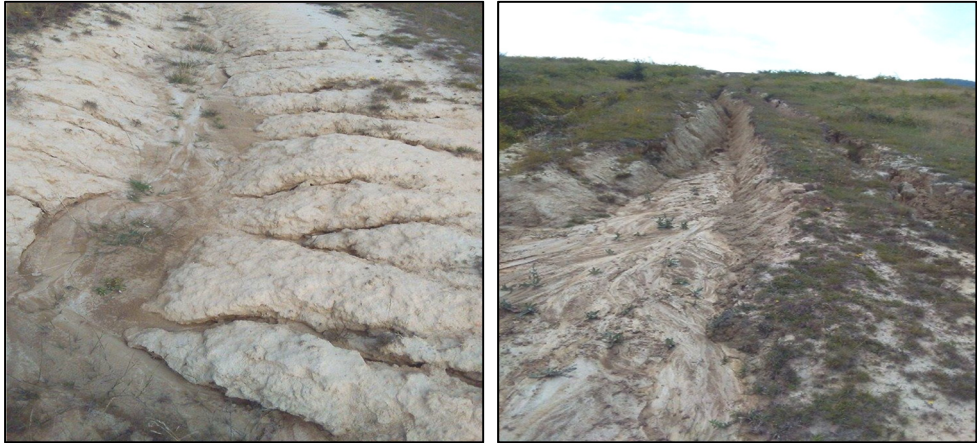
Fig. 5. Gullies

Superficial erosion processes occur across the entire study area, but are more prominent in its southern and eastern parts (fig. 5).

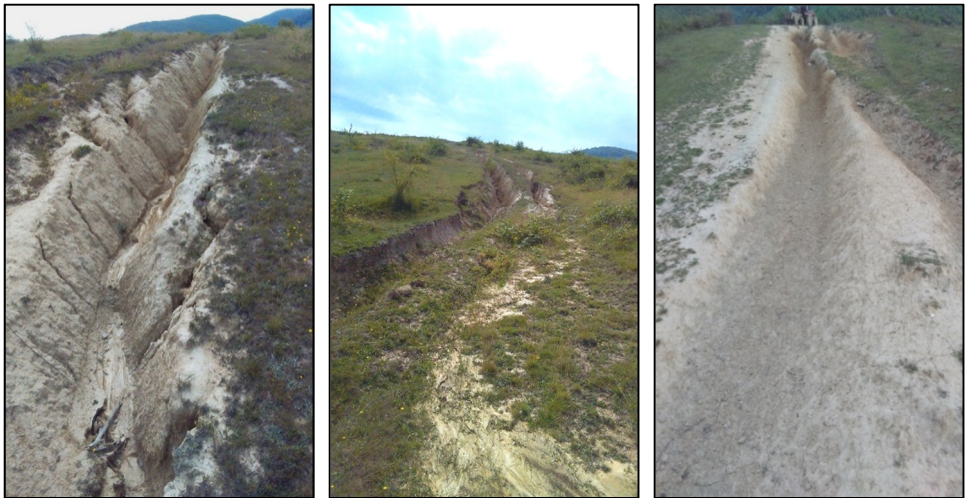
Fig. 6. Former dirt roads leading to the forest, affected by gullies

Figure 6 depicts the areas most prone to surface erosion, which are areas covered by pastures. Besides the existing type of vegetation, slope declivity and irrational overgrazing are the causes of said process. However, human activities have the highest impact. At Chelița, gullies were formed on dirt roads leading to the nearby forest; due to the large quantities of wood carried each year on these roads, water was able to easily create gullies and ditches (fig. 6).

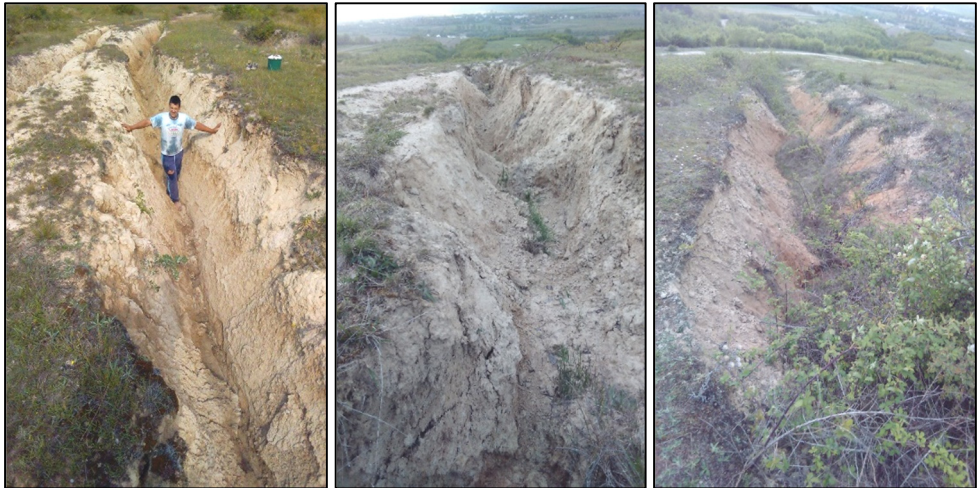
Fig. 7. Gullies in Chelînța

Gullies are the main form created by depth erosion, this type of process being facilitated by the sedimentary formations from the hills in the area. Most active gullies can be found in Chelînța and Vicea. Their depth varies between 2-5 meters, reaching over 50 meters in length and 2-5 meters in width (fig. 7). The entire slope is scarred by these landforms and are further exacerbated by overgrazing and log transportation.

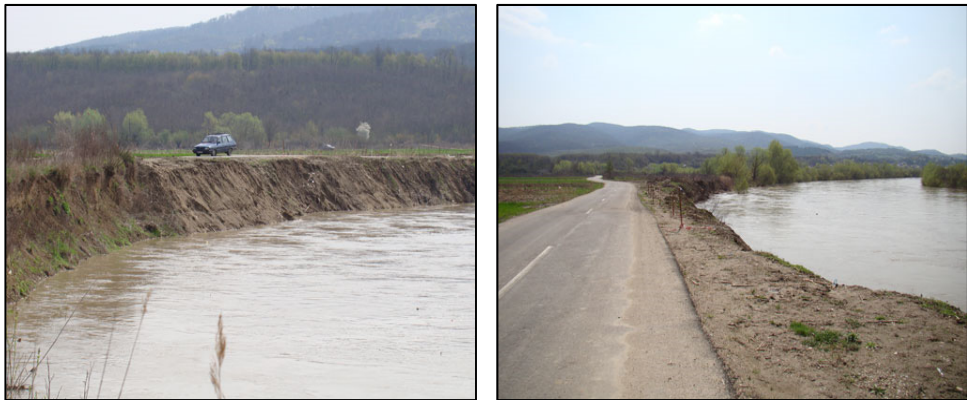
Fig. 10. Shore erosion during the 2010 flood, near Ulmeni

On the sector of the Someș River between Țicău and Ardușat there are two phenomena that affect the riverbed. Firstly, there are enbankment works; despite their scarcity, they had major effects on the riverbed. The first sector, between Țicău and Mireșu Mare, has two areas with visible signs of human intervention. On the right bank of the river, near the town of Ulmeni, a series of river improvement works were implemented such as the creation of a sandbag wall which reduces erosion of the river bank (MMP, 2013). Such measures are necessary as, in the spring of 2010, river flow increased dramatically due to torrential rains and snow melting. During the month of April 2010, the village of Chelița, part of the town of Ulmeni, was in danger of becoming isolated as flash floods damaged the only access route in the area, that is the road to Ulmeni, and Mireșu Mare (Lazăr, 2016) (fig. 10).

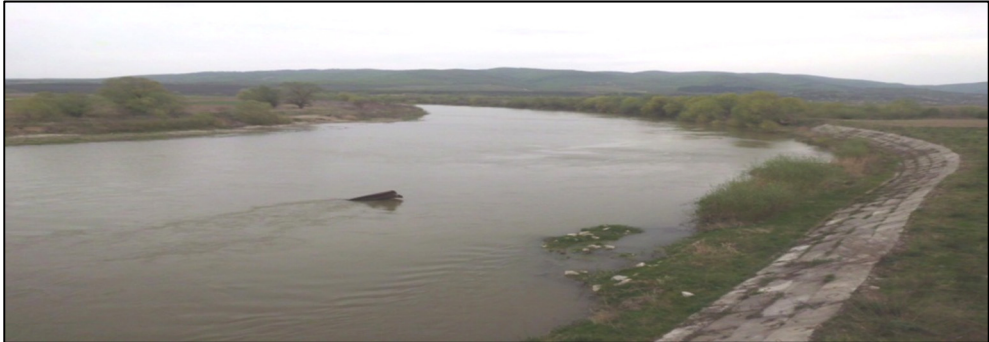
Fig. 11. Stabilization works of the left river bank at Ulmeni

A similar situation occurred roughly 500 meters downstream, on the left bank of the river this time; the bank was stabilized with concrete slabs in order to diminish the side erosion caused by the river (fig. 11) (Lazăr, 2016).

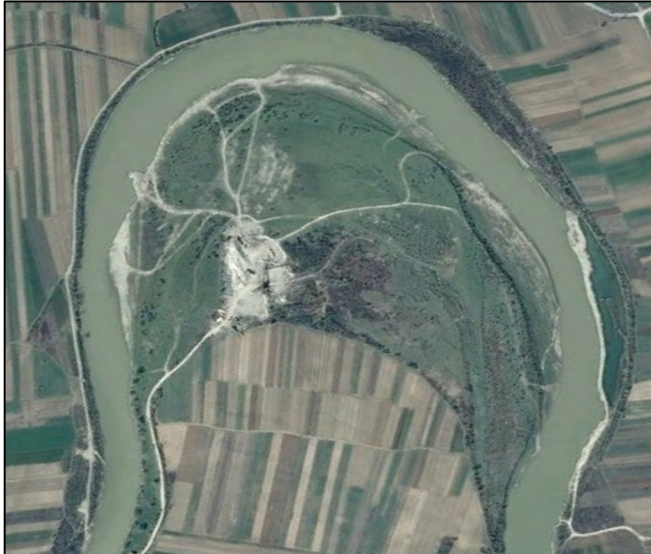
Fig. 12. Slip-off slope and sand point bar on the right bank of the Someș River, near Pribilești
Source: Google Earth

The second sector, the one between Mireșu Mare and Tămaia-Mogoșești suffers from excessive extraction of alluvial deposits. According to the list of planning permits issued in 2013 by the Maramureș County Councils (<http://www.cjmaramures.ro/activitate/urbanism/lista-cu-certIFICATELE-DE-URBANISM-SI-AUTORIZATIILE-DE-CONSTRUIRE-DESFIINTARE-EMISE>), there are three such pits in development, located on the right bank of Someș River, two in Lucăcești and one in Dăneștii Chioarului, located less than 2 km from each other. Dăneștii Chioarului pit sits on a richer deposit, as it is located on a slip-off slope (fig. 12). Downstream, near Pribilești, there is another functioning gravel pit (Lazăr, 2016).

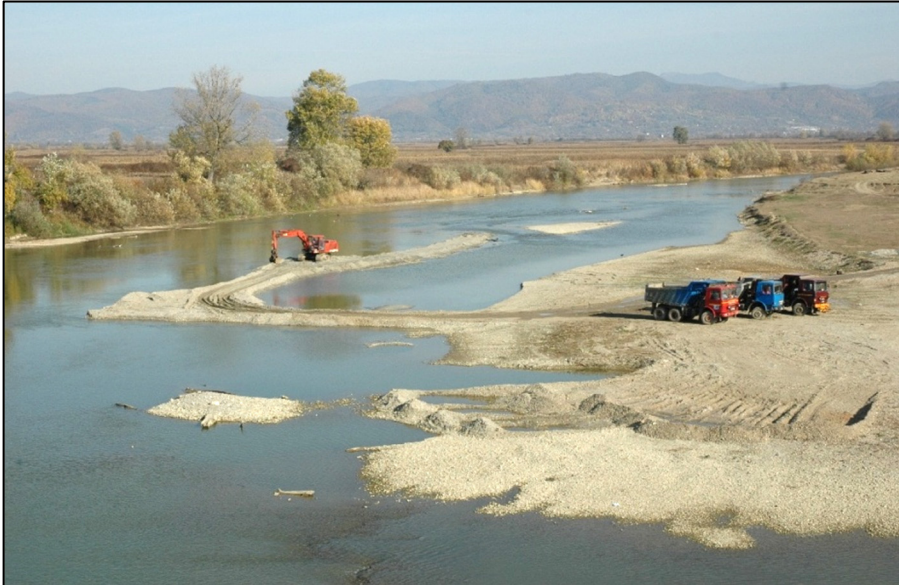
Fig. 13. Alluvial deposits extraction by artificial headlands

The left bank has a similar situation, as Fărcașa hosts a concrete plant which uses sand from a pit located downstream. The company running these two locations also administers the gravel pits of Pribilești, Mogoșești and Sîrbi. This sector, due to the environmental impact of man-made structures and human intervention, is heavily destabilized, and contains areas affected by artificial deepening which, in time, may undermine the banks and the slopes. As the alluvial deposits located along Someș River are suitable for constructions, a few extraction points emerged chaotically in several locations. The same situation can be found downstream of Tămaia, on the left side of the river, where, all the way to Ardușat, there are four more gravel pits and one asphalt production facility. The extraction is done by excavators. For an effortless extraction from the riverbed, several dirt roads were built, some of them right next to the river (fig. 13) (Lazăr, 2016).

The landforms generated by these pits are extremely varied; the most visible are the existing excavations in active as well as in abandoned pits (Lazăr, 2016).

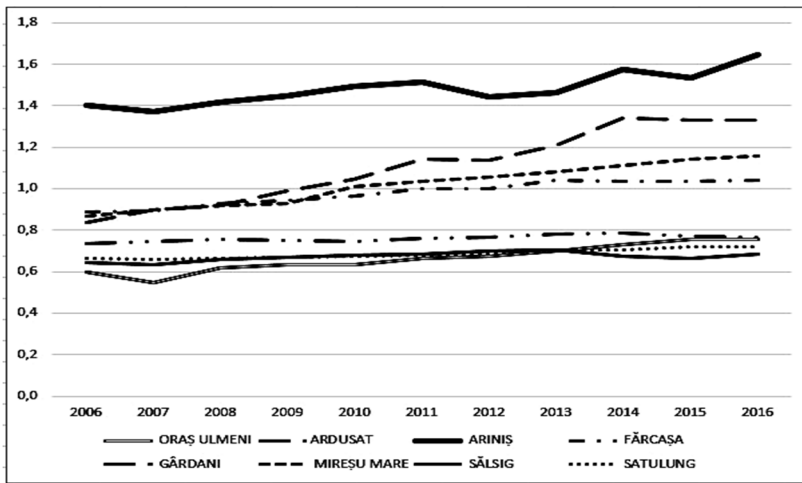
Fig. 14. The demographic aging index

The degree of population aging was represented by calculating the population aging index for all eight administrative-territorial units for a period of 10 years (2006-2016). The report date was the 1st of July each year. According to the graph below, one can notice that all administrative-territorial units have a higher index than the 0.42 threshold value (fig. 14). Thus, the demographic aging phenomenon is quite severe.

The commune with the highest index is Ariniș; between 2006 and 2016, its index increased, reaching the value of 1.6 on the 1st of July 2016. This commune is followed by Gârdani, which experienced considerable growth until 2014, when it reached 1.3. In the following two years however, its index decreased. The lowest value was registered in Ulmeni, with a value below 1, but its index has been continually rising since 2007.
