WEATHERING PROCESSES AND THEIR EFFECTS ON STONE-BUILT CULTURAL HERITAGE. CASE STUDY: "SAINT ARCHANGELS" CHURCH, DEAG VILLAGE

3.1. Case study: “Holy Archangels Michael and Gabriel Church”, Deag Village

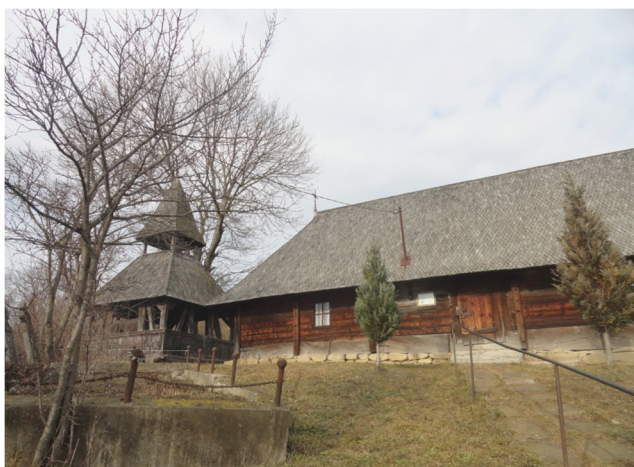
Fig. 1. “Holy Archangels Michael and Gabriel Church”, South - East view.

The church was built, according to tradition, on a promontory. The walls were built with wooden beams arranged according to the blockbau system. The foundation is built with irregular blocks of stone, extracted from the nearby hills.

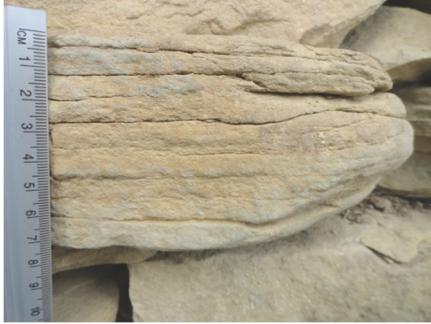
Delamination is predominant on the southern and northern parts of the foundation. The rocks with southern exposure are few in number but are severely affected (fig. 2). Some of the bedding planes completely detached and fell to the ground. The loss of lithic material has left a number of holes into the foundation (fig. 3). According to Torracca (2009), delamination is caused by the repeated action of freeze – thaw cycles (frost weathering). Aroldi (2005) attributes it to both frost weathering and termoclasty. The latter can be justified only in the case of the rocks that are situated on the southern side of the foundation which are exposed to direct solar radiation.

Fig. 2. Severe delamination along the bedding planes.

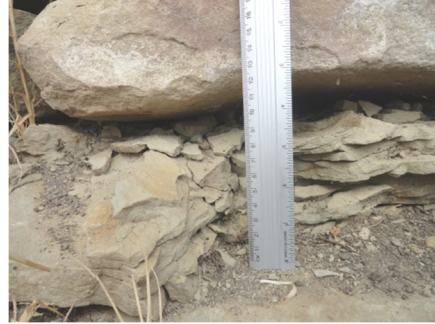
Fig. 3. Partial disintegration caused by severe delamination.

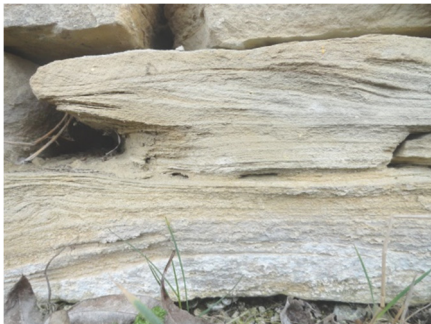
Some of the rocks located on the northern side of the foundation have been affected by both delamination and *granular disintegration*. The association of these two weathering forms has created a sculptural and sandy surface (fig. 4). White *efflorescence stains* have been noticed on a small number of rocks located at the lower part of the foundation. They are the result of the dissolution of the calcium carbonate and may indicate a more severe deterioration beneath the surface (fig. 5). Oxidation has affected a large number of rocks, on all sides of the foundation, causing chromatic modification but did not involve any visible surface deterioration.

Fig. 4. Delamination and granular disintegration.

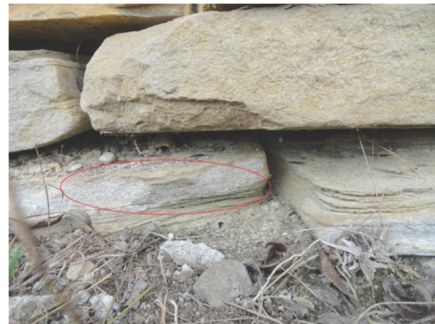
Fig. 5. White efflorescence caused by the dissolution of calcium carbonate.

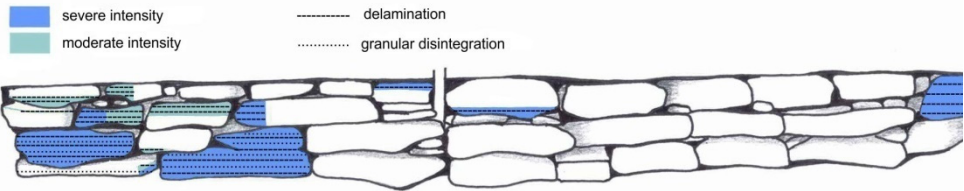
The *in situ* macroscopic investigation was finalised with the mapping of the weathering forms, a method intended for monitoring their evolution (fig. 6 and 7). The middle section of the northern side was chosen for this purpose because it includes all identified weathering forms.

Fig. 6. Physical weathering forms.

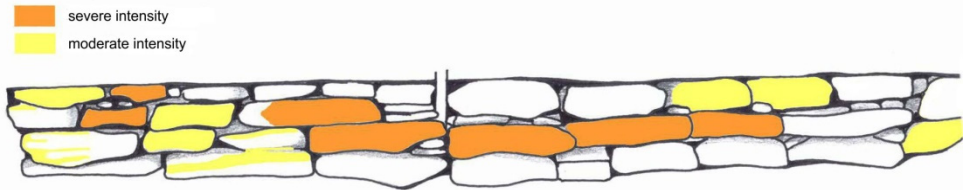
Fig. 7. Chromatic alteration caused oxidation.

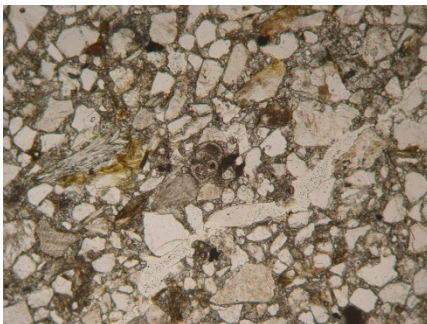
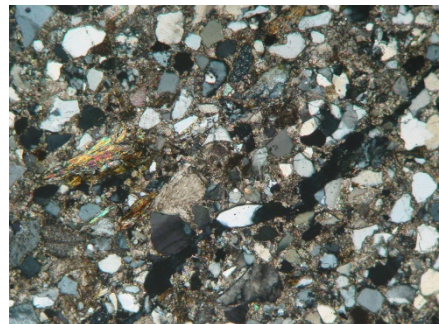
Thin sections of the samples were analysed using a Zeiss Axiolab Microscope. The following structural components were identified: mica, feldspar, quartz and bioclast fragments, cemented together with calcium carbonate (fig. 8 and 9).

Fig. 8. Microscope analysis in plane – polarized light. Fig. 9. Microscope analysis in crossed – polarized light. Both photos show: mica, quartz and bioclast fragments.

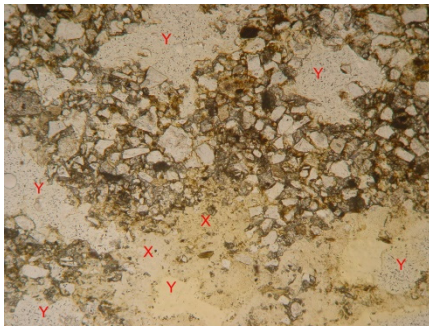
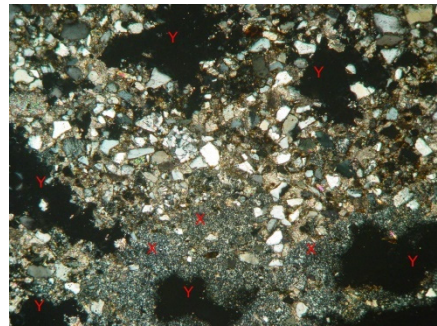
The microscope analysis of the samples has identified the presence of secondary gypsum crystals (*subefflorescence*) (fig. 10 and 11). The pressure exerted by the newly formed crystals is rather dangerous as it may cause structural damage by breaking down the walls of the pores. The *dissolution of calcium carbonate* has left empty spaces between the particles (dissolution pores), thus weakening the sandstone's mechanical resistance and facilitating further weathering (fig. 10 and 11). The lack of cement is one of the causes of granular disintegration. *Oxidation* was caused by both chemical and biological weathering. Microscope images show the presence of iron bacteria (fig. 12 and 13).

Fig. 10. Microscope analysis in plane - polarized light. **Fig. 11.** Microscope analysis in crossed - polarized light. Both photos show: X - gypsum crystals; Y - dissolution pores.

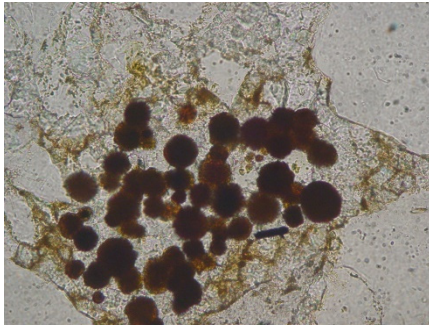
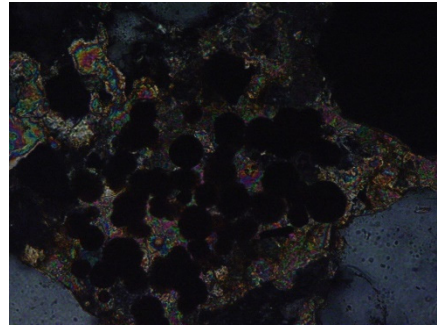
Fig. 12. Microscope analysis in plane - polarized light. **Fig. 13.** Microscope analysis in crossed - polarized light. Both photos show iron bacteria.
