DEBRIS FLOW ACTIVITY RECONSTRUCTION USING DENDROGEOMORPHOLOGICAL METHODS. STUDY CASE (PIULE IORGOVANU MOUNTAINS)

ABSTRACT. – **Debris Flow Activity Reconstruction Using Dendrogeomorphological Methods. Study Case (Piule Iorgovanu Mountains).** Debris flows are one of the most destructive mass-movements that manifest in the mountainous regions around the world. As they usually occur on the steep slopes of the mountain streams where human settlements are scarce, they are hardly monitored. But when they do interact with built-up areas or transportation corridors they cause enormous damages and even casualties. The rise of human pressure in the hazardous regions has led to an increase in the severity of the negative consequences related to debris flows. Consequently, a complete database for hazard assessment of the areas which show evidence of debris flow activity is needed. Because of the lack of archival records knowledge about their frequency remains poor. One of the most precise methods used in the reconstruction of past debris flow activity are dendrogeomorphological methods. Using growth anomalies of the affected trees, a valuable event chronology can be obtained. Therefore, it i

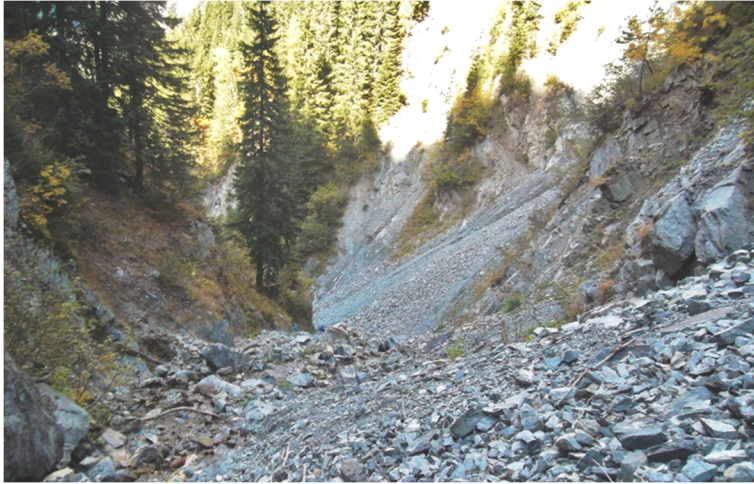
Fig.1. Proluvial deposits along the channel

The torrent surface is mainly built of metamorphic rocks (80%) represented here by crystalline schists and sedimentary rocks (20%). Also in the middle part of the basin, especially along the channel there are huge amounts of proluvial deposits (fig. 1). These unconsolidated materials are the main sources of debris flows initiation as they can be easily mobilised during rapid flows. The debris fan is composed of non-sorted debris of all sizes ranging from the sand size to blocks of over 1 m in diameter. Because of the lithological structure, both the channel of transport and the slopes have high degrees of declivity, the mean value being of 18°. The forest standing on the cone and bordering the channel mainly consists of Norway spruce (*Piceaabies* (L.) Karst.).

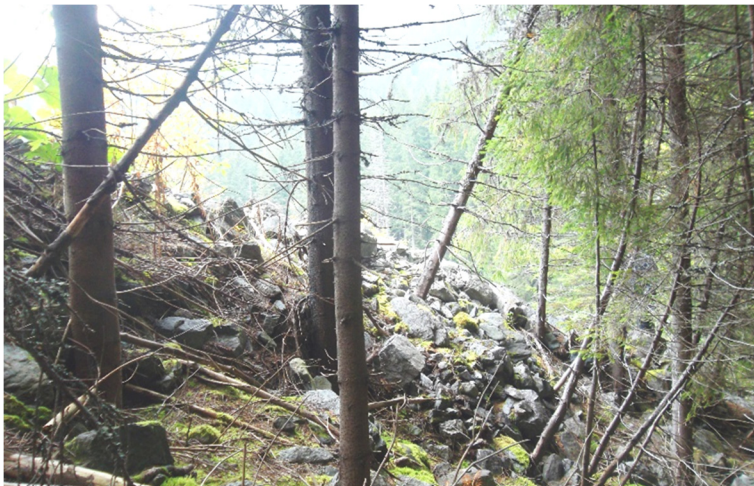
Fig. 2. Deposits on the right side of the cone

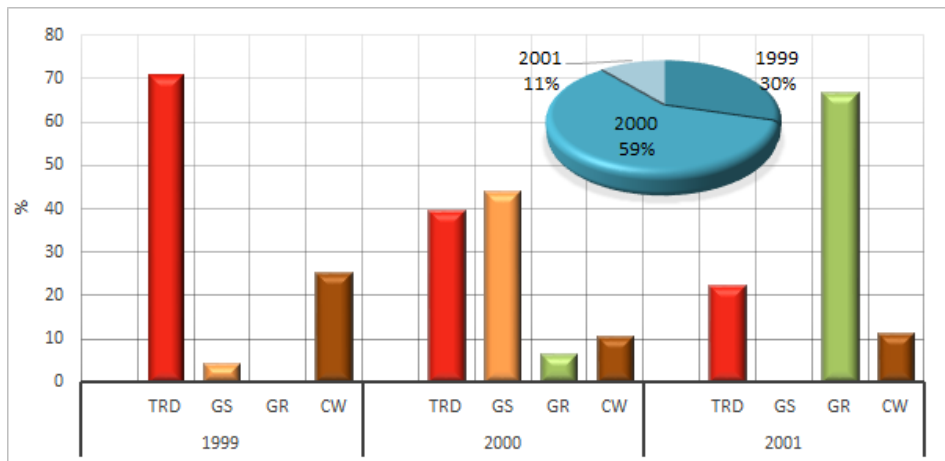
Fig. 7. The percentage of the trees responding to the event that occurred in July 1999 and the percentage of the growth anomalies found in the interval 1999-2001

The most numerous growth anomalies were identified in the interval 1999-2001, when 52 spruces (75%) reacted through different types of disturbances. As shown in the figure 7, most of the trees reacted in 2000 with 59%, followed by 1999 (30%). Also, in 1999 most of the trees reacted through TRD and CW, while in the next year there were more cases of GS and other TRD. Interestingly, even in 2001 there were encountered some new TRD but most of the reactions (67%) were in form of growth release (GR). Moreover, the intensity of the disturbances was very high, in many cases the TRD and GS was maintained for several years consecutively or even till the sampling year. Other reconstructed years after this major event were 2006 and 2011 to which we add 2008 as possible event year.

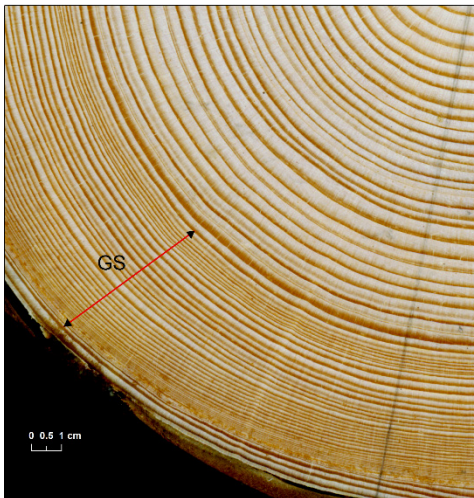
Fig. 9. Severe growth reduction found in a cross section starting from 1972

The results interpretation can be really difficult when the trees are severely affected and the rings width is too narrow (fig. 9). There can be missing or false rings which complicates even more the analysis. In the increment cores these types of disturbances are hard to detect while the cross sections provide more useful information (fig. 10). Also, in the cross sections the intensity of the reactions can be more precisely established offering a clearer picture of the responsible event. As most of the growth anomalies are discovered using the microscope, the human error is another factor which might affect the reconstruction process. The events reconstruction represents a minimum frequency of debris flows occurrences as it depends on the interaction between the process and the riparian vegetation.
