IS “CONSERVATION IN RUIN” ALWAYS THE BEST SOLUTION? THE CASE OF THE ROMANESQUE CHURCH IN GÂRBOVA

ABSTRACT. *Is “Conservation in Ruin” Always the Best Solution? The Case of the Romanesque Church in Gârbova.* As the leading institution in charge of built heritage protection in Romania after 1952, the Directorate of Historical Monuments (DHM) took essential steps in funding, designing, and conducting various conservation works on sites endangered by earthquakes, looting, improper use, or defective historic restorations. Partially demolished by the local community in the previous centuries and seriously affected by neglect, the Romanesque Lutheran church in Gârbova, Alba County, was in the 1960s on the verge of collapse. After a thorough cause analysis, the DHM managed to prevent disaster by undertaking a rescue intervention in line with the international trends of the time. Thus, the site became one of the first DHM projects to design the preservation of a church in a state of ruin rather than its complete reconstruction.

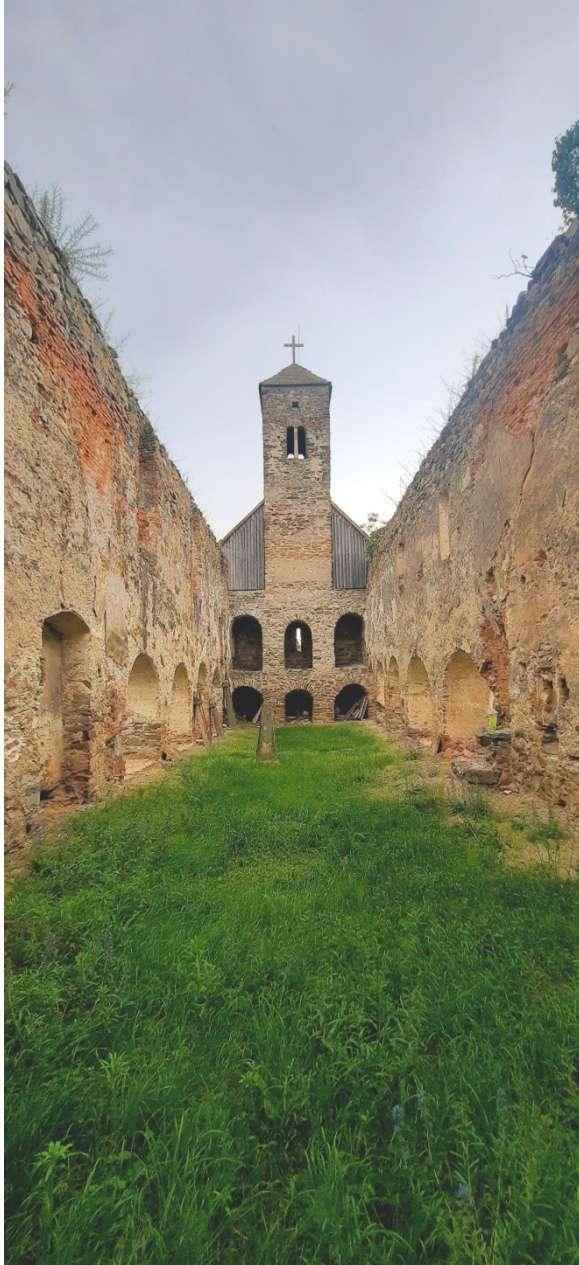
Fig. 1. Inside the church's main nave, view from the east, 2023. (photo: I. Rus-Cacovean).

Built around 1280 in Romanesque style, the church in Gârbova,¹ Alba County, was a basilica with a nave, two side aisles, a semi-circular apse, and a belfry. The church had a western gallery subdivided into three small bays with cross vaults and semi-circular arches and a slender tower rising only above the middle one. Below the gallery, the two pillars and three cross vaults formed a sort of narthex distinct from the central nave. There was no trace of a staircase leading to the gallery, meaning access was only through a wooden ladder. The side aisles also bear traces of cross vaults, while the central nave, separated from the collaterals by pillars, had a wooden ceiling.

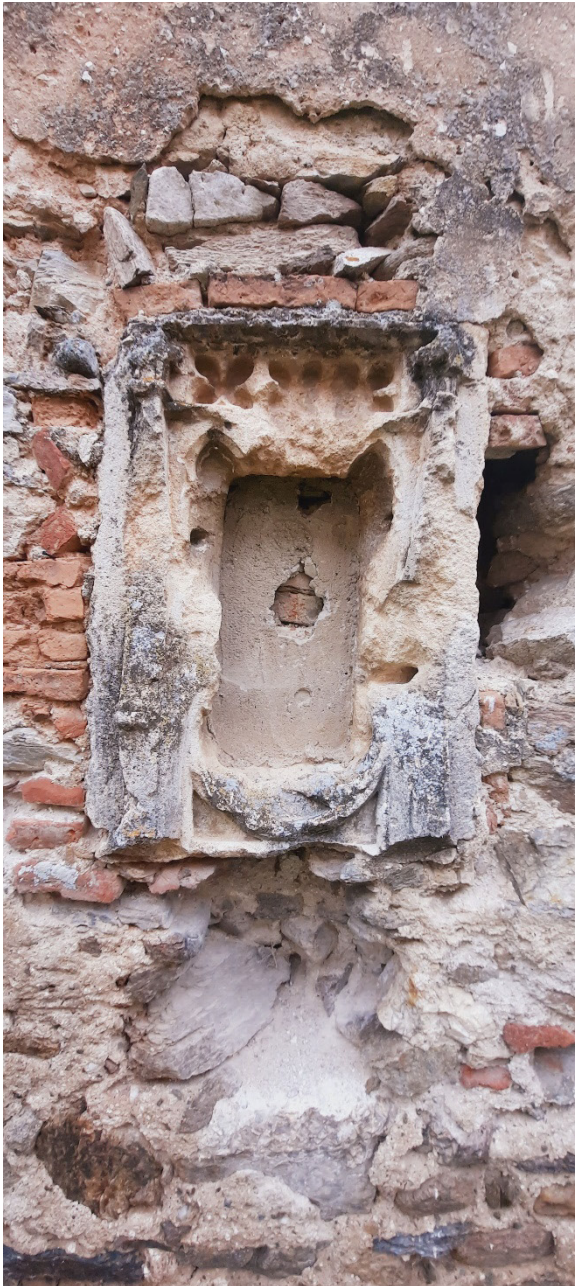
Fig. 5. The stone frame of the Gothic tabernacle on the main nave's northern wall, 2023. (photo: I. Rus-Cacovean).

The church received a new polygonal chancel in the 15th century, now in ruins, but which preserves the trefoiled door towards the sacristy and the traces of a Gothic tabernacle. The walls of the nave still have some of the semi-circular Romanesque windows, while the belfry has twinned windows and colonettes with cubic capitals on all four sides.²

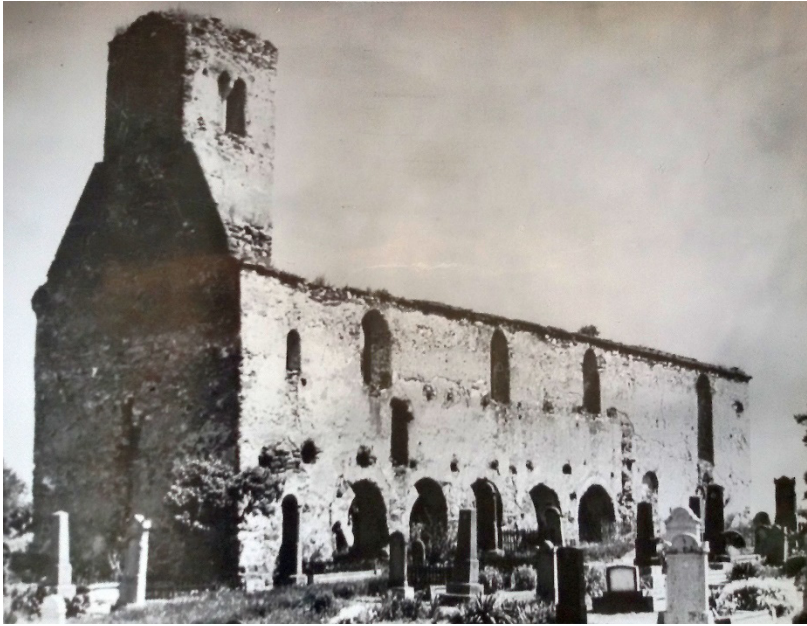
Fig. 6. The church in the early 1960s. (Photo in *Proiect 41A/1965*, DHM Fund, File no. 5079).

Finally, the DHM drew up Project 41A for further consolidation works, with Chefneux as chief architect. The file included photographs, a description, a history of the church and the works carried out until then.³¹ For this phase, the project included provisions for complete archaeological investigations.³² But now the real problems arose since the design proposed two variants, which launched a heated debate on the final appearance of the church and the number of works to be done.

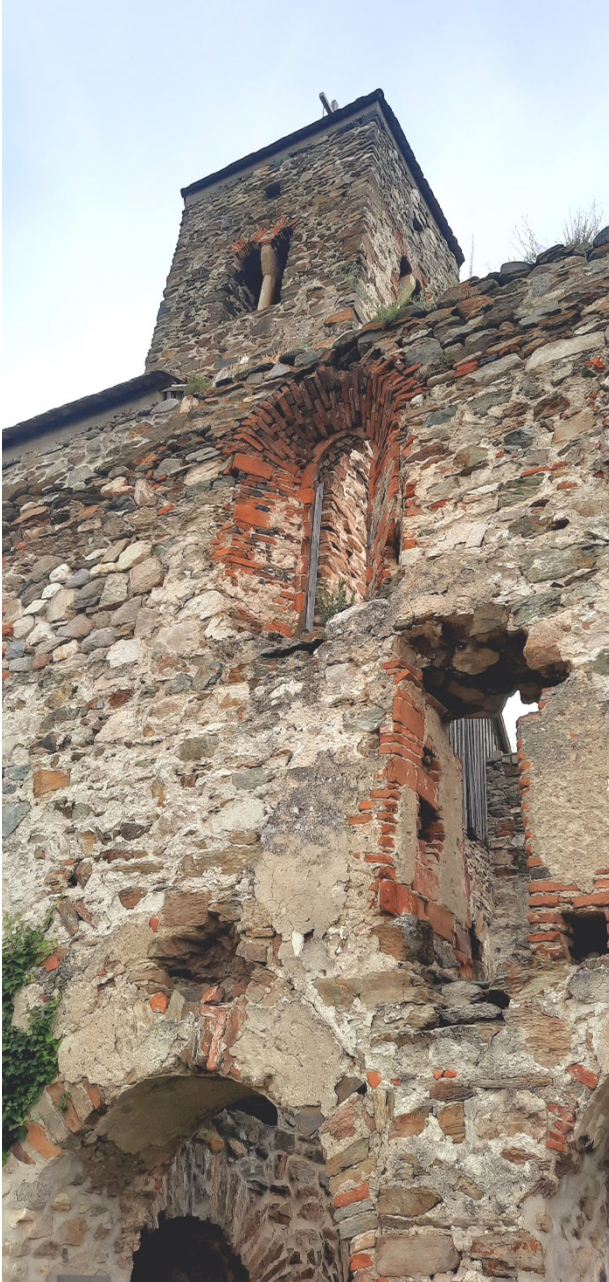
Fig. 10. Details of the consolidation with concrete beams, view from the south, 2023. (photo: I. Rus-Cacovean).

The project was finally implemented only in 1966: in some parts the walls were consolidated and received reinforced concrete belts, the cracks were filled, while in others the masonry was demolished, rebuilt, and grouted. The works included the minimum archaeological research, a tiled roof over the sacristy, the rebuilding of the tower’s windows, uncovering up to the walking level of the side walls, paving with stone slabs, sewerage, and wall canopies.⁴⁹
