COLOUR IN MURAL PAINTING: VIRTUE IN CONSERVATION AND RESTORATION

VICTORIA GRĂDINAR*

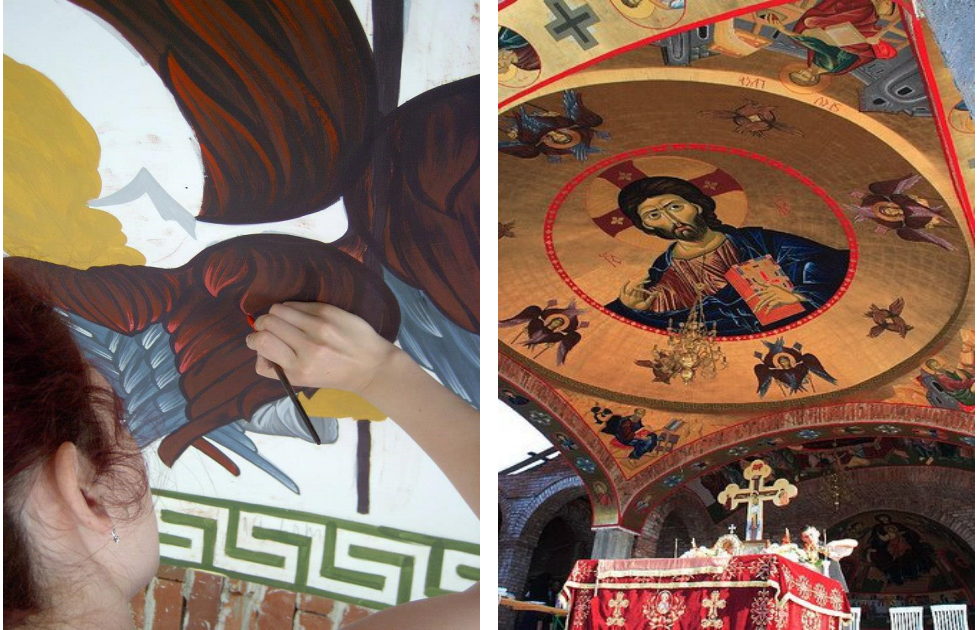
Images during the mural painting at *The Summer Altar*,
Bixad Monastery, Satu-Mare County.
