STUDY ON PEDOLOGICAL SOIL PROPERTIES IN THE “HANEȘ” MINE AREA FOR ITS REMEDIATION

**Adriana Mihaela CHIRILĂ BĂBĂU^{1*}, Valer MICLE¹,
Ioana Monica SUR¹**

¹*Technical University of Cluj Napoca, 103-105, Muncii Avenue, 400641,
Cluj Napoca, Romania*

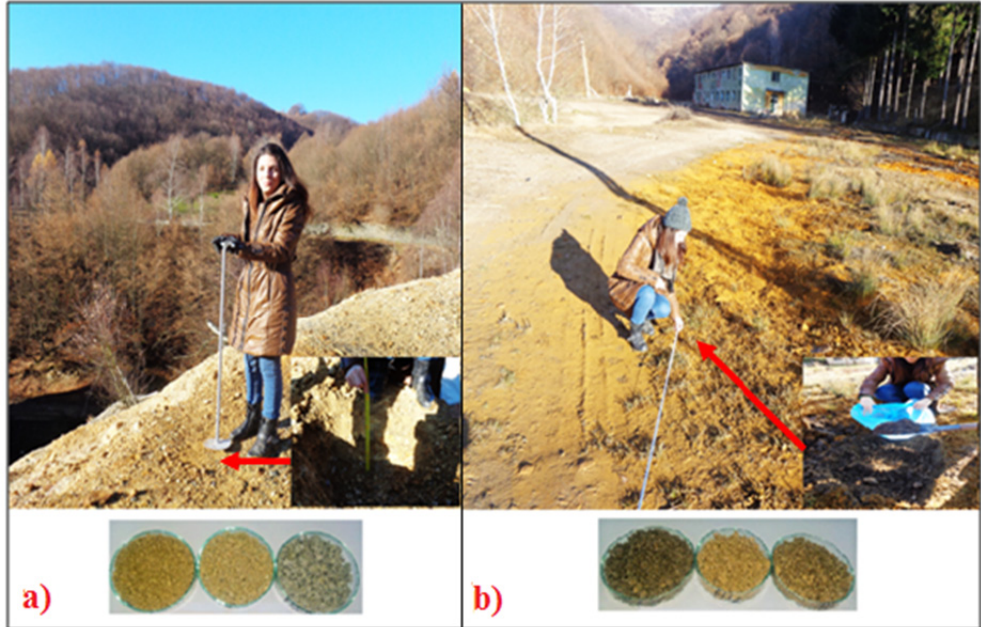
Fig. 1. *The sampling points image: a) soil samples taken from the dump, situated at 150 m distance of the "Haneş" mine; b) soil samples taken from 100 m distance of the Haneş mine.*

From „Haneș” mine area were taken for analysis six samples. Three samples were taken from the Haneș dump, at a distance of about 150 m from mine and of three different depths, such as: 0-10 cm, 10-30 cm and 30-100 cm. The other three samples were taken from a distance of about 100 m from the Haneș mine (between the dump and mine), the same depth.

Soil sampling for pedological analysis is present in figure 1.

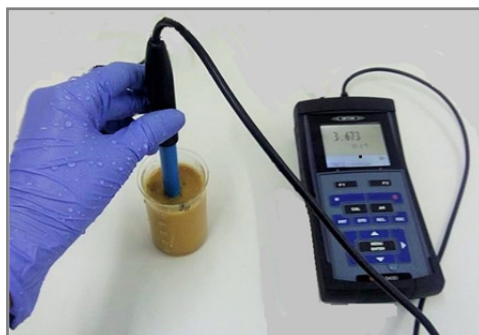
The pH was determined by WTW 2FD47F Multi 3430 Multiparameter Meter (figure 2).

Fig. 2. *The Determination of pH in laboratory*

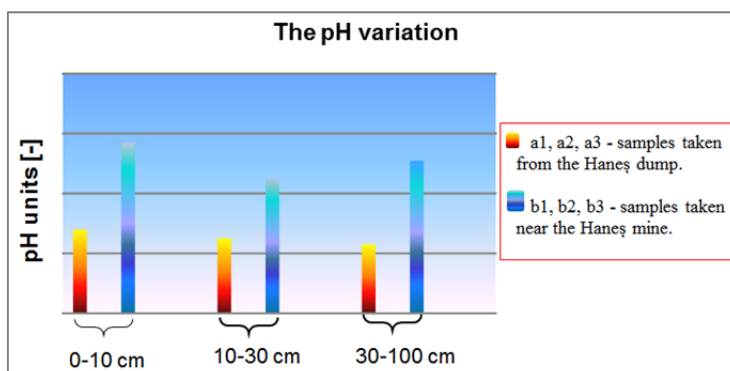
Fig. 3. *The pH values obtained from analysis of soil samples taken.*

pH values obtained indicate that the pH of the dump material and soil which is near the Haneş mine is acid to very acid.

pH of the dump material is in the range 2.3 - 2.8 pH units and in the range of 4.5 - 5.7 is the soil samples taken near the mine.

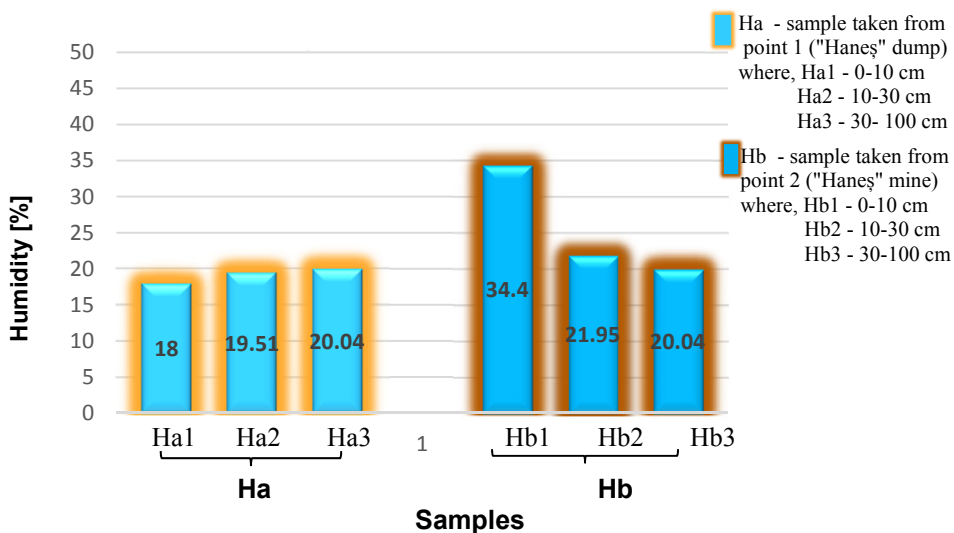
Fig. 4. The moisture content in point 1 and 2

The results obtained at the determination of soil humidity content from soil samples and waste material from the sampling points 1 and 2 (near the „Haneş” mine and the Haneş sterile dump) are presented in figure 4.

The results at the determination of soil humidity content showed that the moisture content of the sterile material taken from point 1 increases with the depth, since on a depth of 0-10 cm the humidity indicated a 18% value, on a depth of 10-30 cm 19.51%, and on a depth of 30-100 cm this indicated a value of 20.04%.

For samples taken from point 2, soil moisture decreases with depth. This indicates a value of 34.4% on the first sampling layer (0-10 cm), 21.95% on the second sampling layer (10-30 cm), and on the third sampling layer (30-100 cm) soil moisture indicated 20.04%.

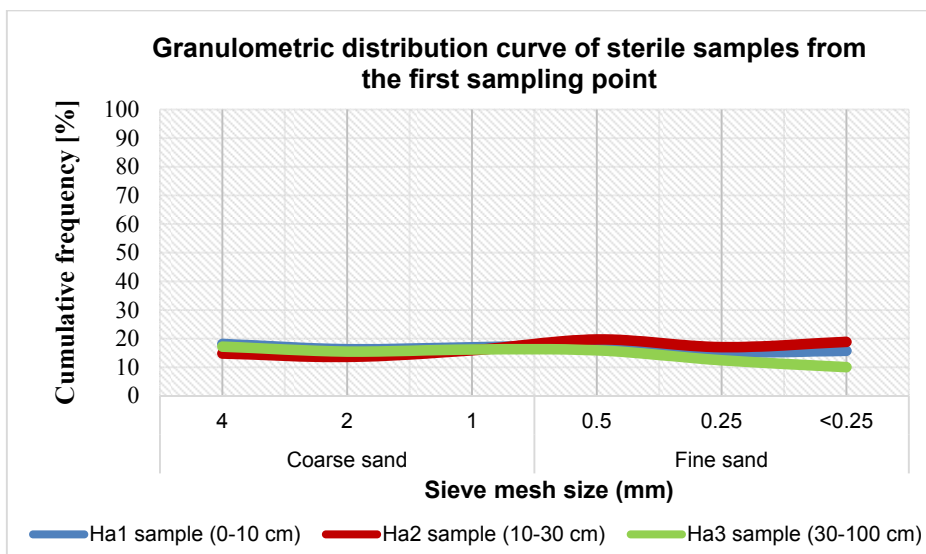
Fig. 6. The granulometric distribution curve characteristic of the first sampling point

The following granulometric distribution curves (figures 6 and 7) characteristic of each point were obtained following the analysis of the determination of the soil texture and sterile material from the samples taken sampling.

The results obtained by analyzing the texture of the sterile material in the samples taken showed it to be a clayey sandy texture consisting of a good water retention capacity.

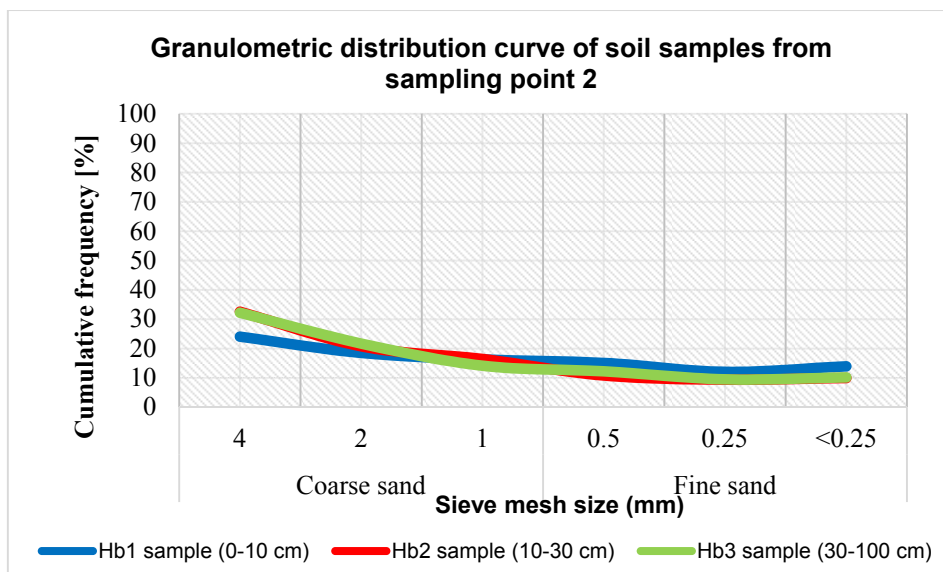
Fig. 7. *The granulometric distribution curve characteristic of the first 2 sampling*

The results obtained in the soil texture analysis from the samples taken showed that the soil has a coarse sandy texture reflecting poor water retention and low fertility.
